**BUZZARDS BAY
RAILROAD LIFT BRIDGE
OVER CAPE COD CANAL**

INSPECTION AND CONDITION REPORT

OCTOBER, 1984

MODJESKI AND MASTERS

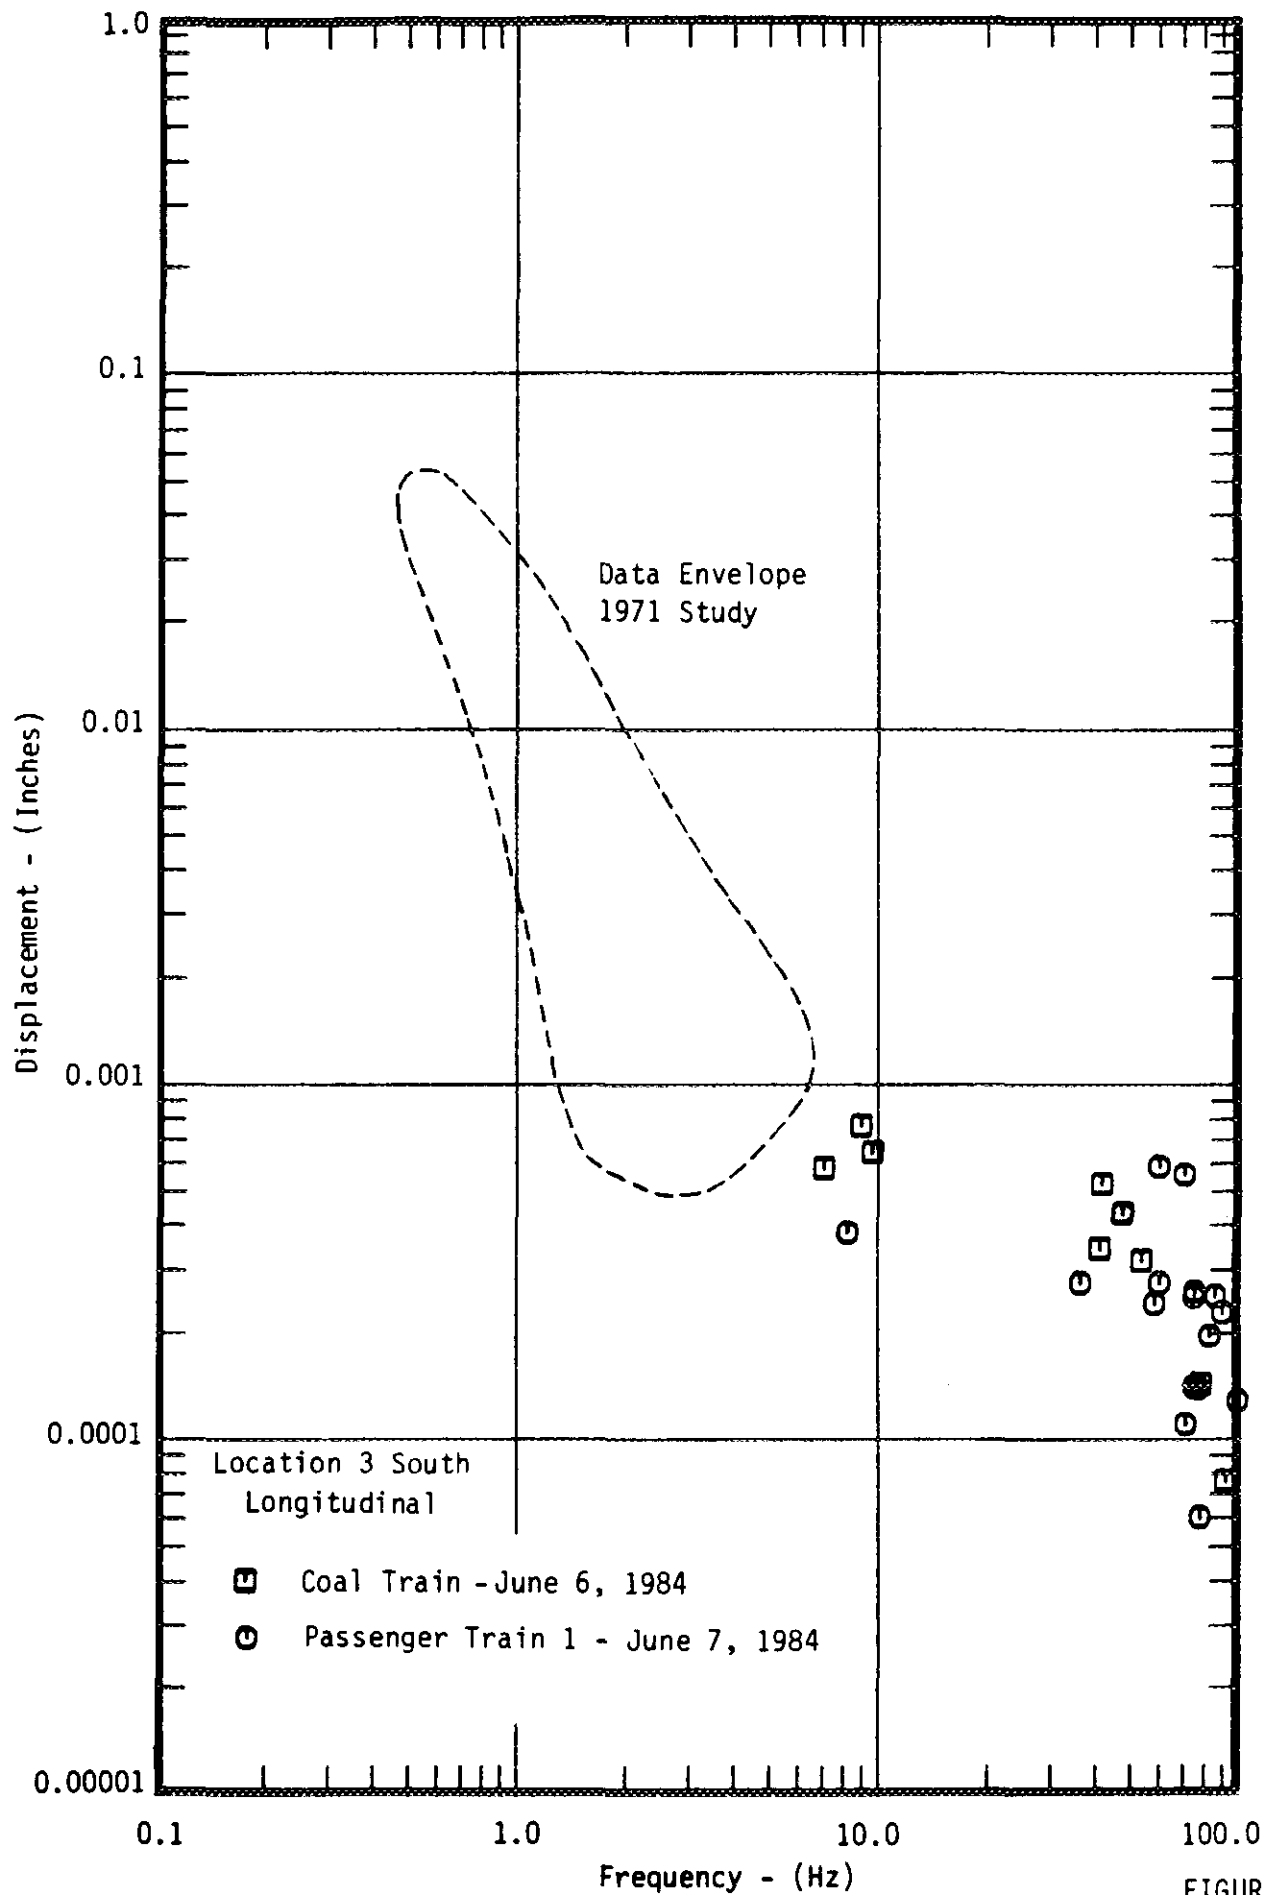
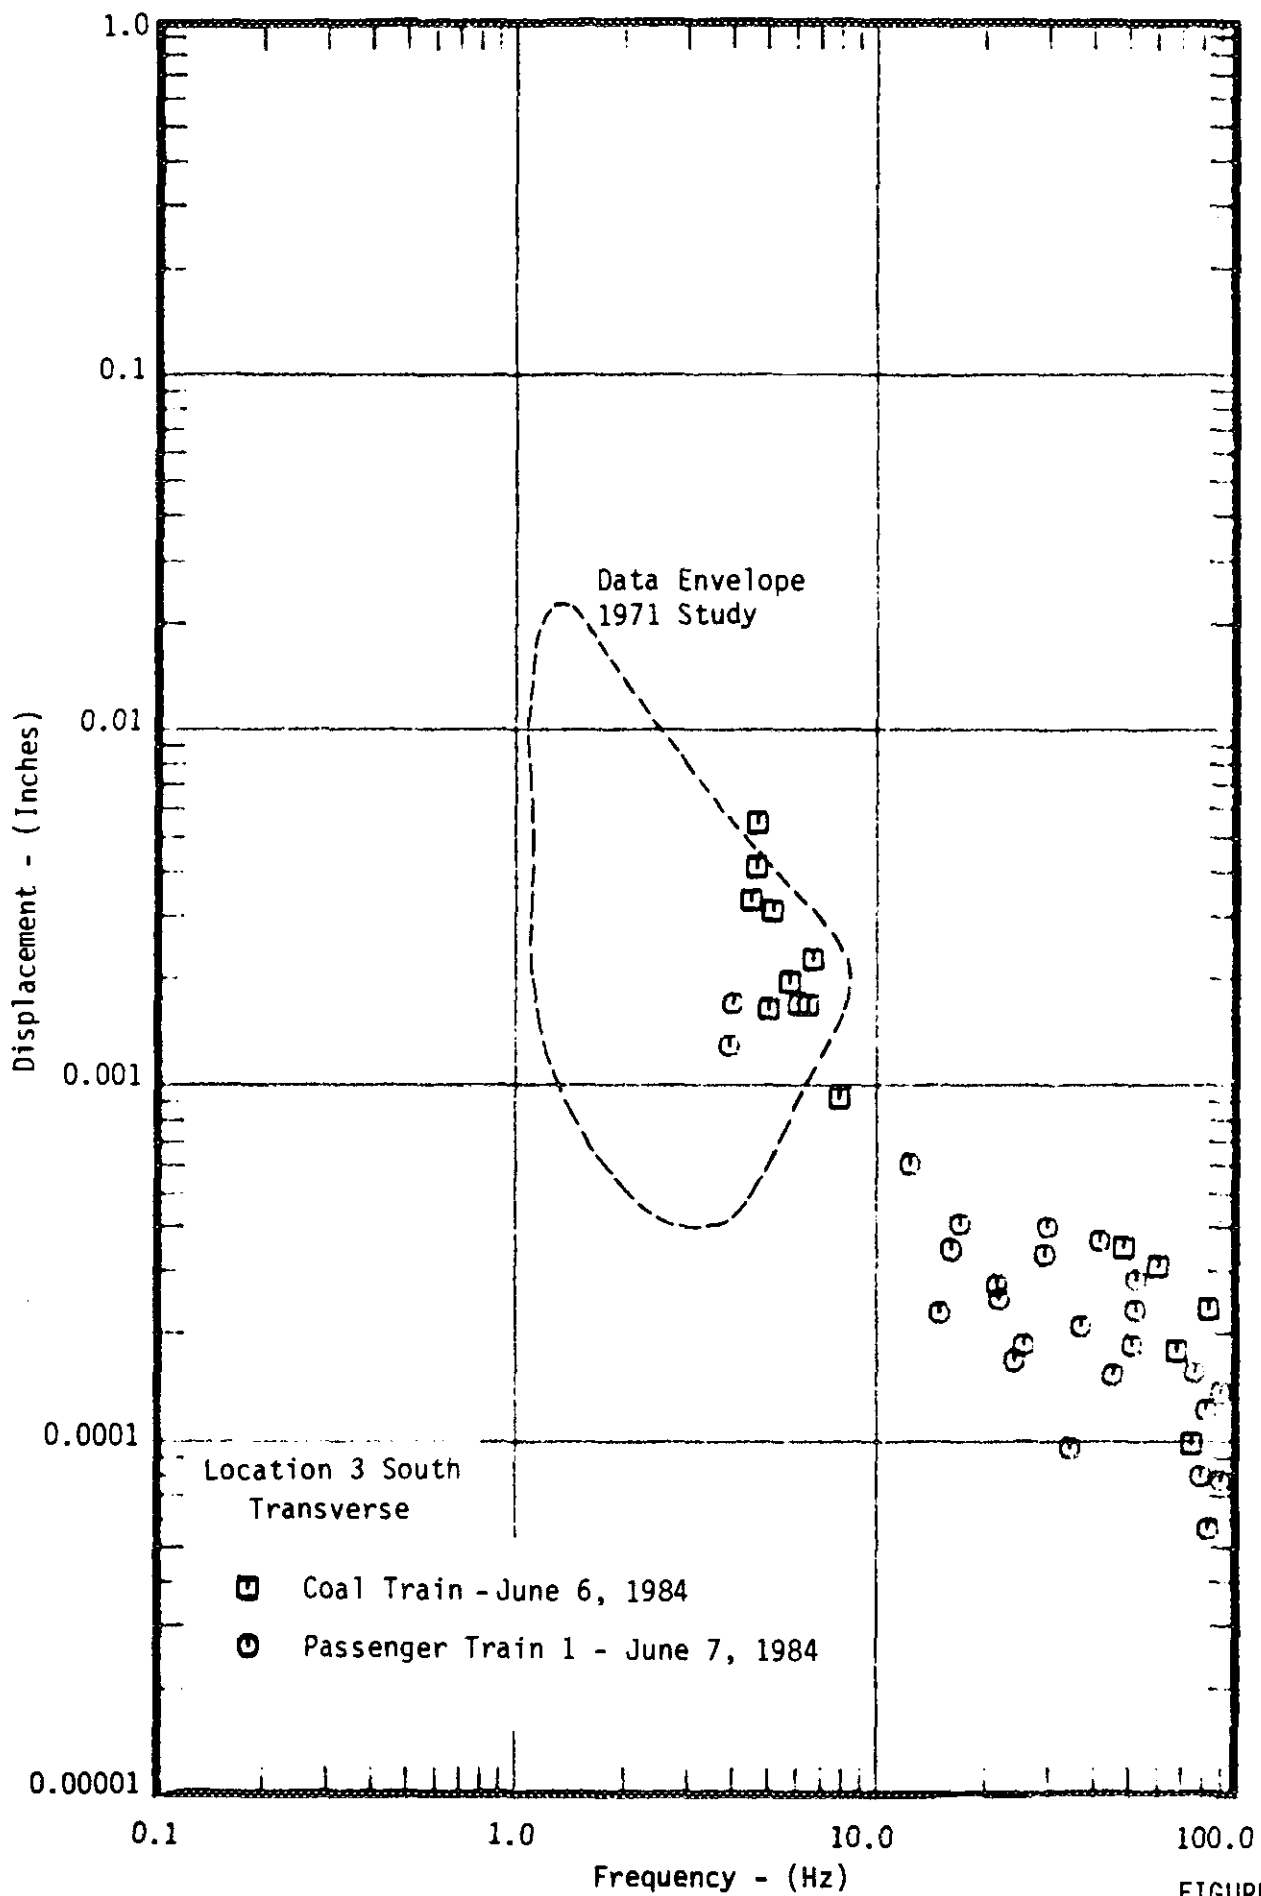
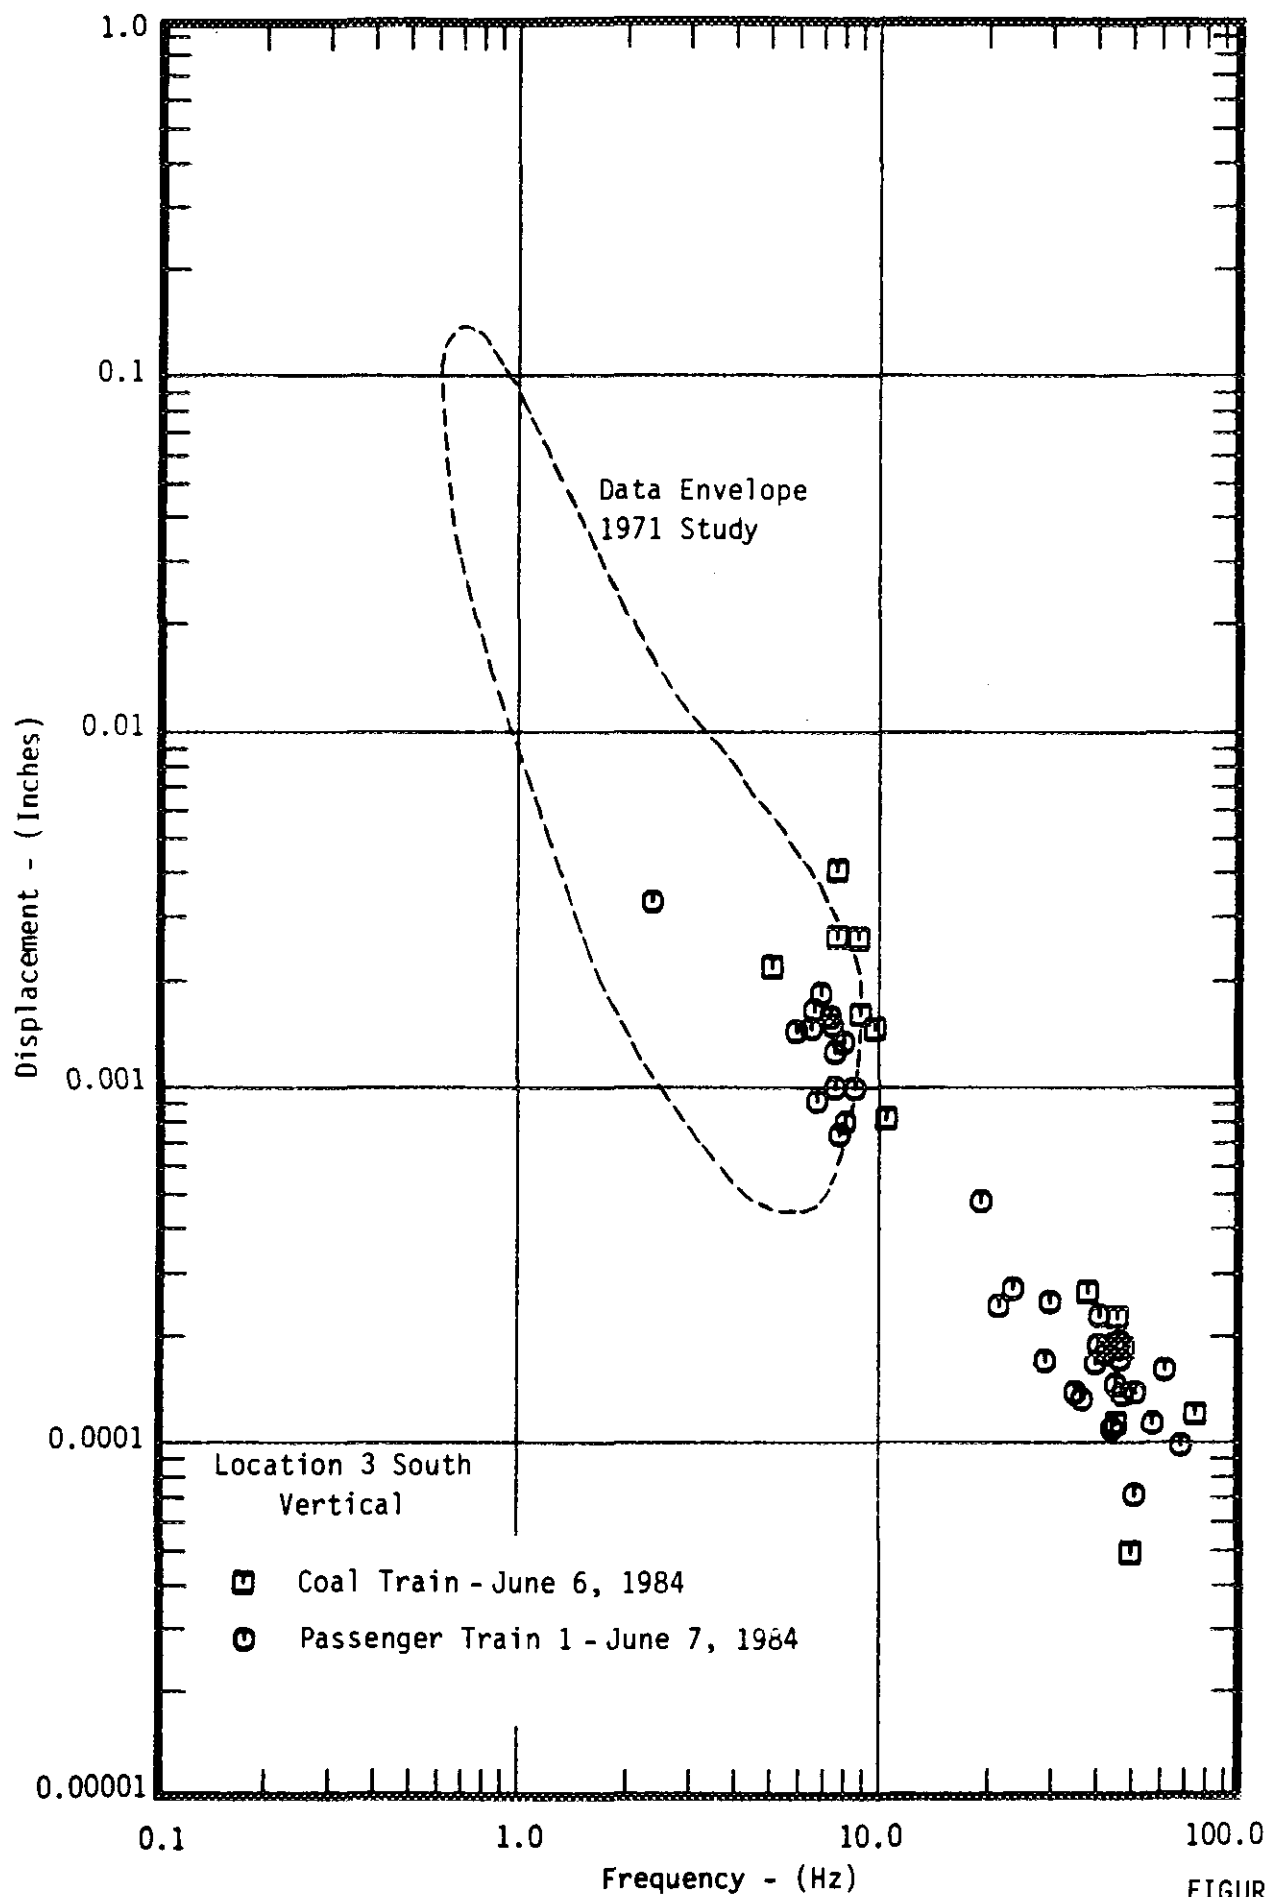
Displacements at Location L3S are plotted on Figures 8→10. Vibrations at this location are similar in amplitude and frequency distribution to those observed at Locations L9 and L3N and are consistent with those reported for this location in the 1971 study.

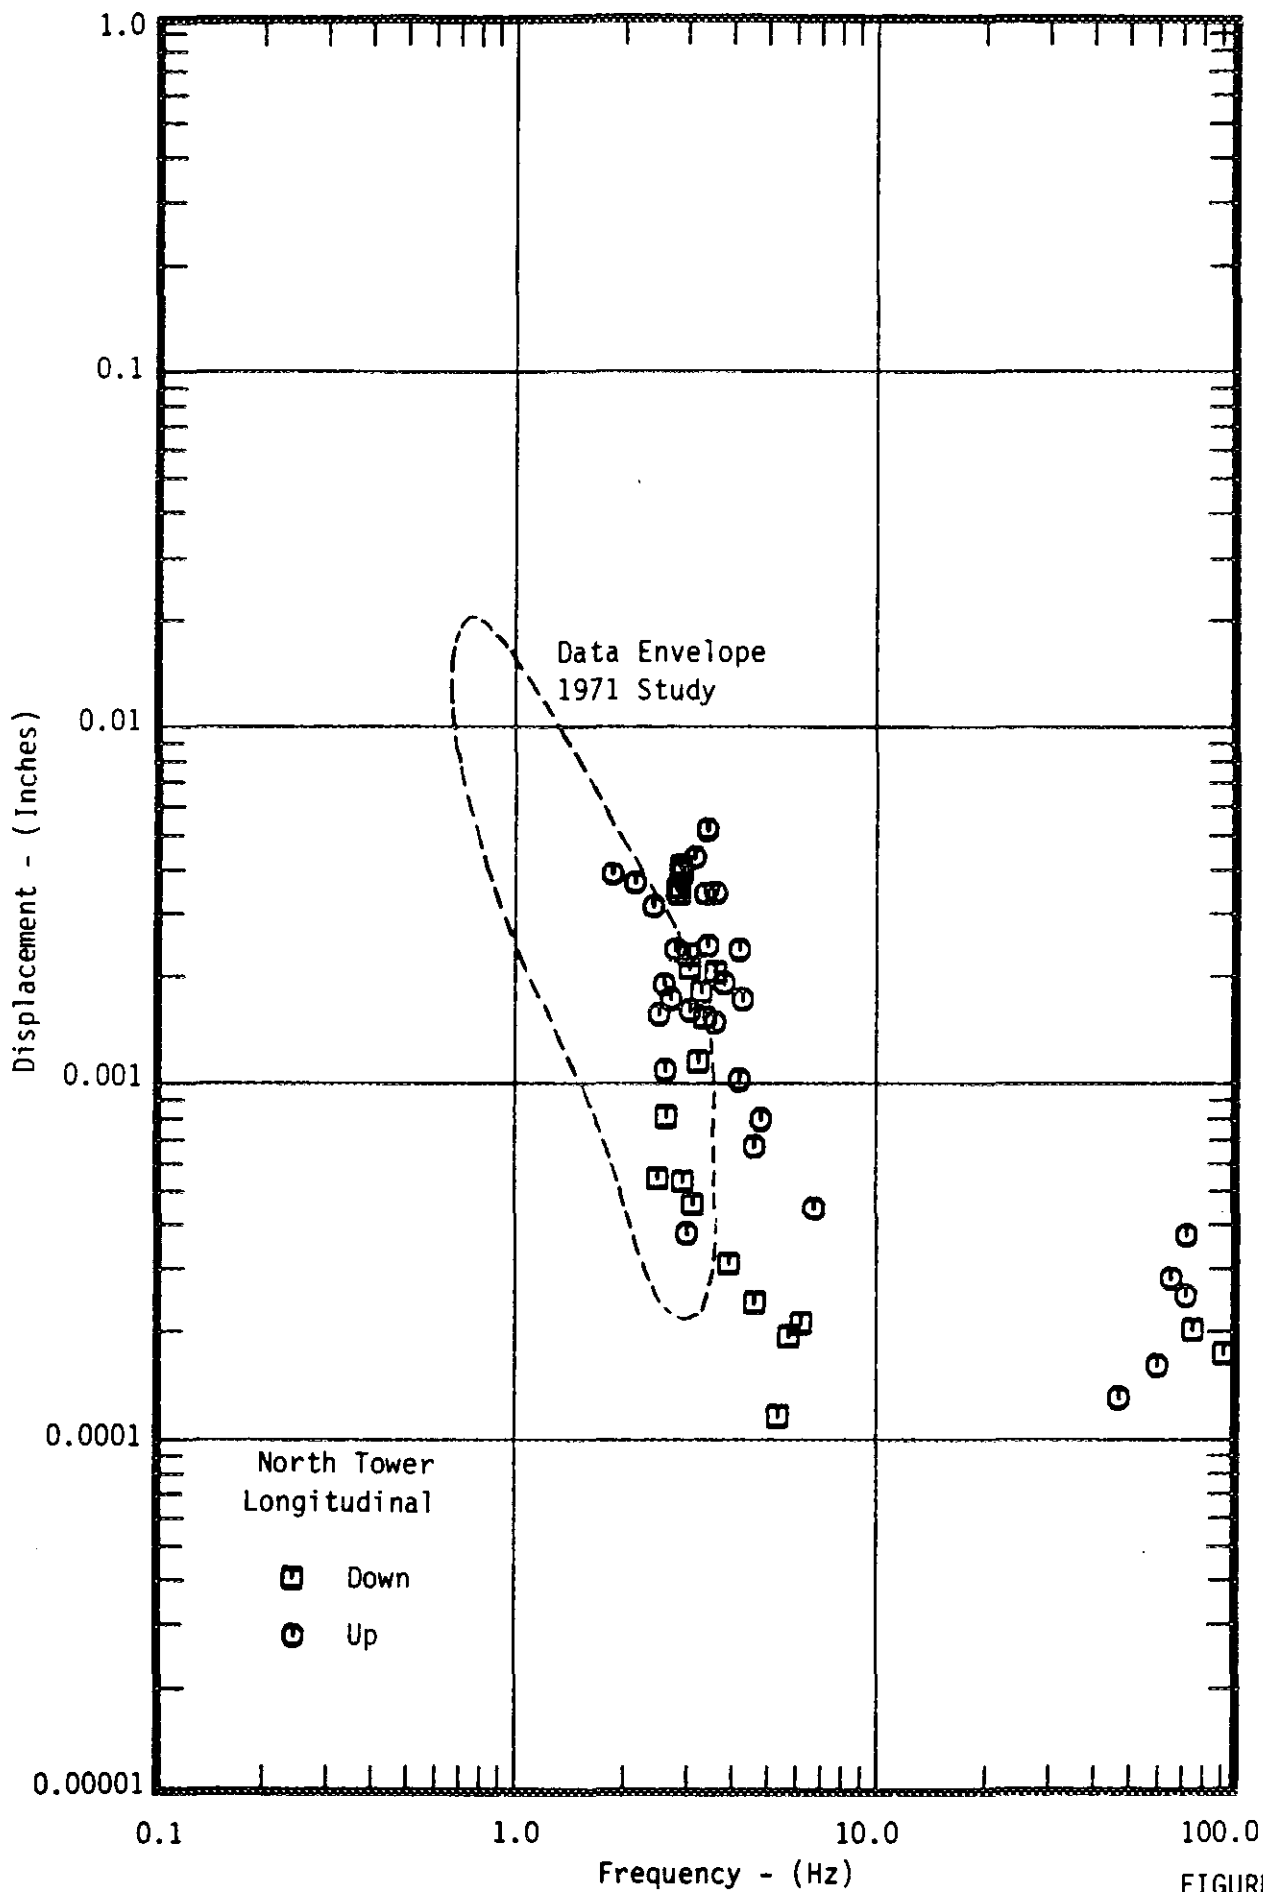
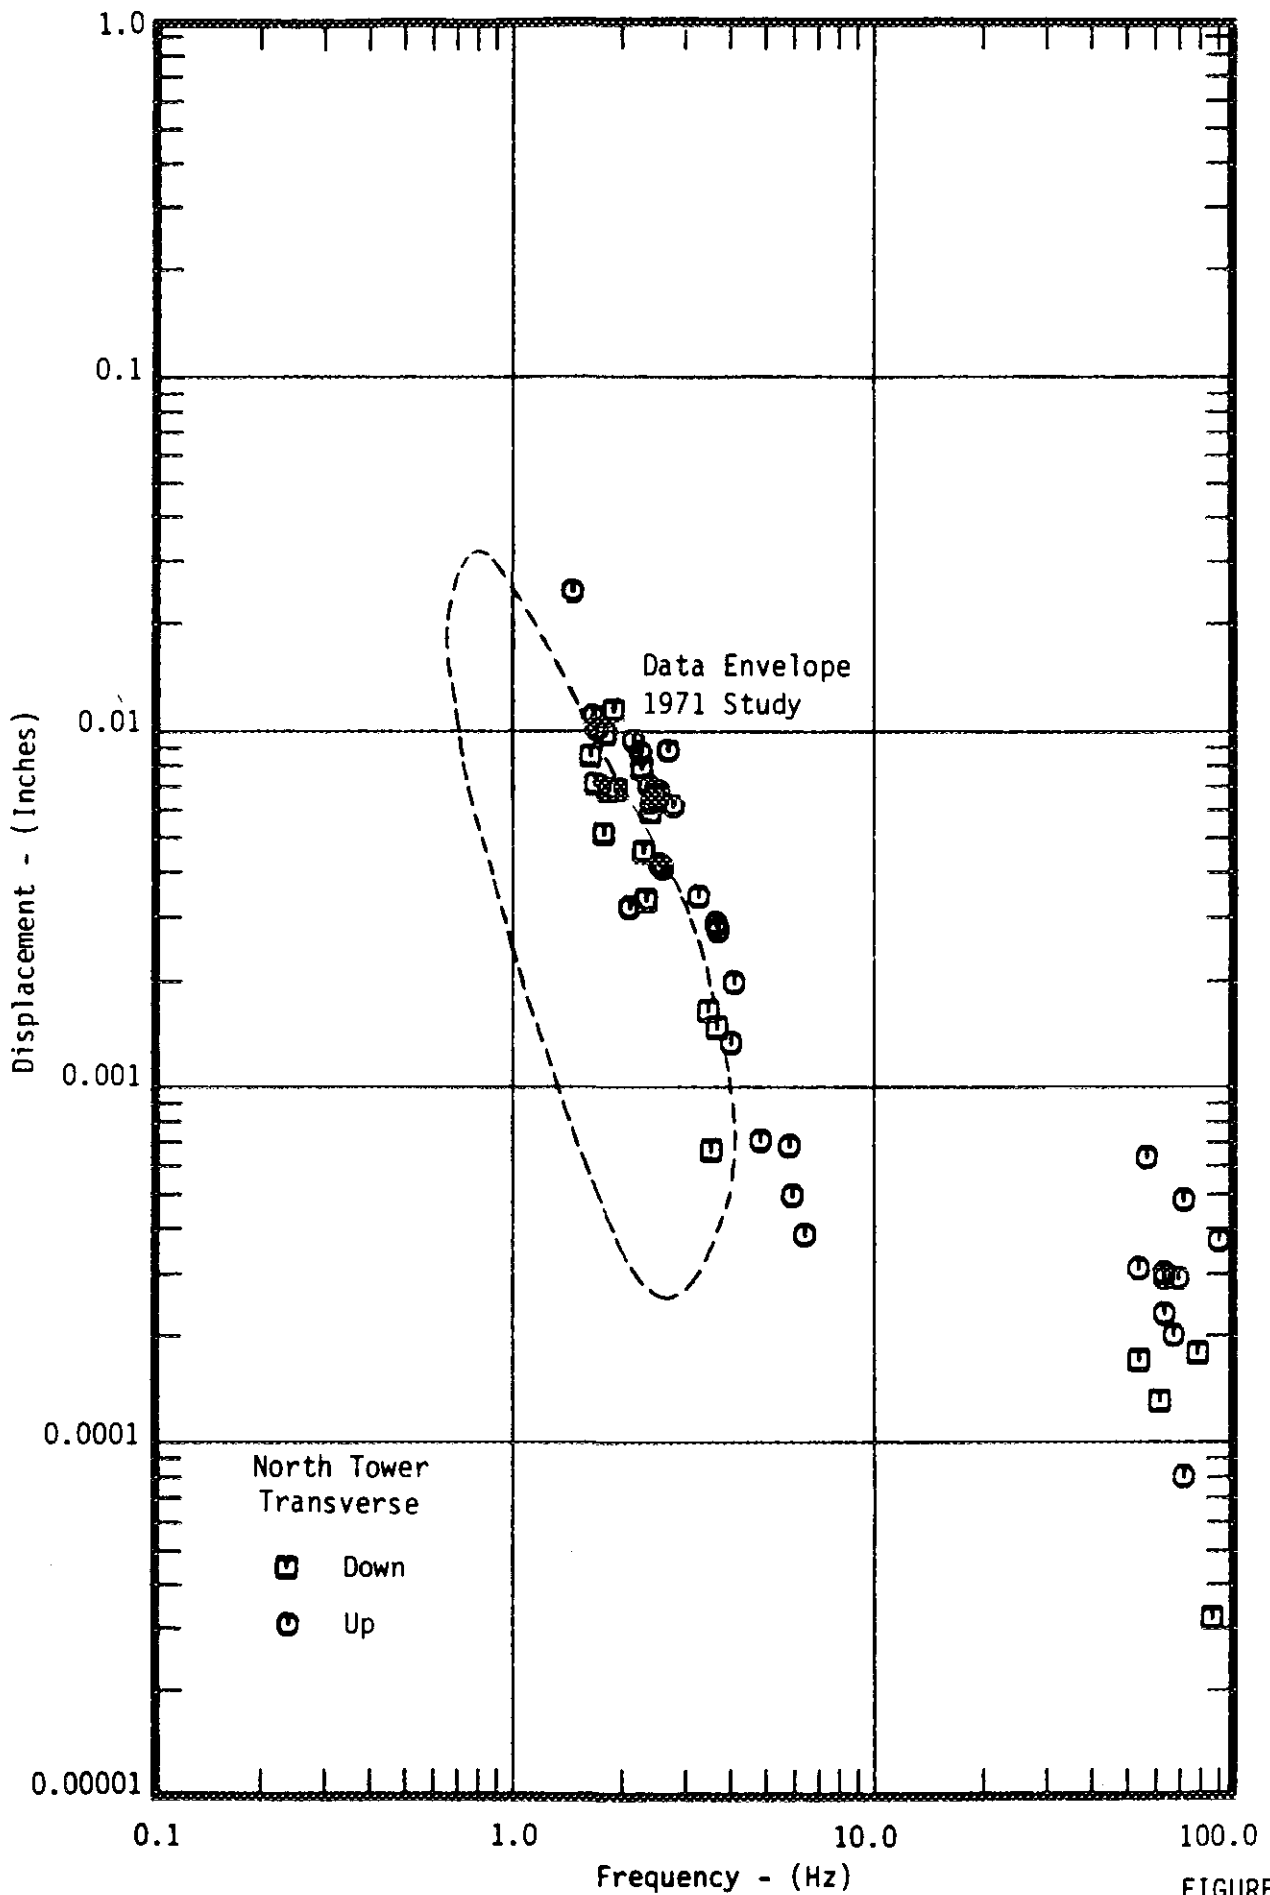
Displacements induced in the North Tower by upward and downward movement of the lift span are shown on Figures 11→13. The results of this present study are consistent with those reported in 1971.

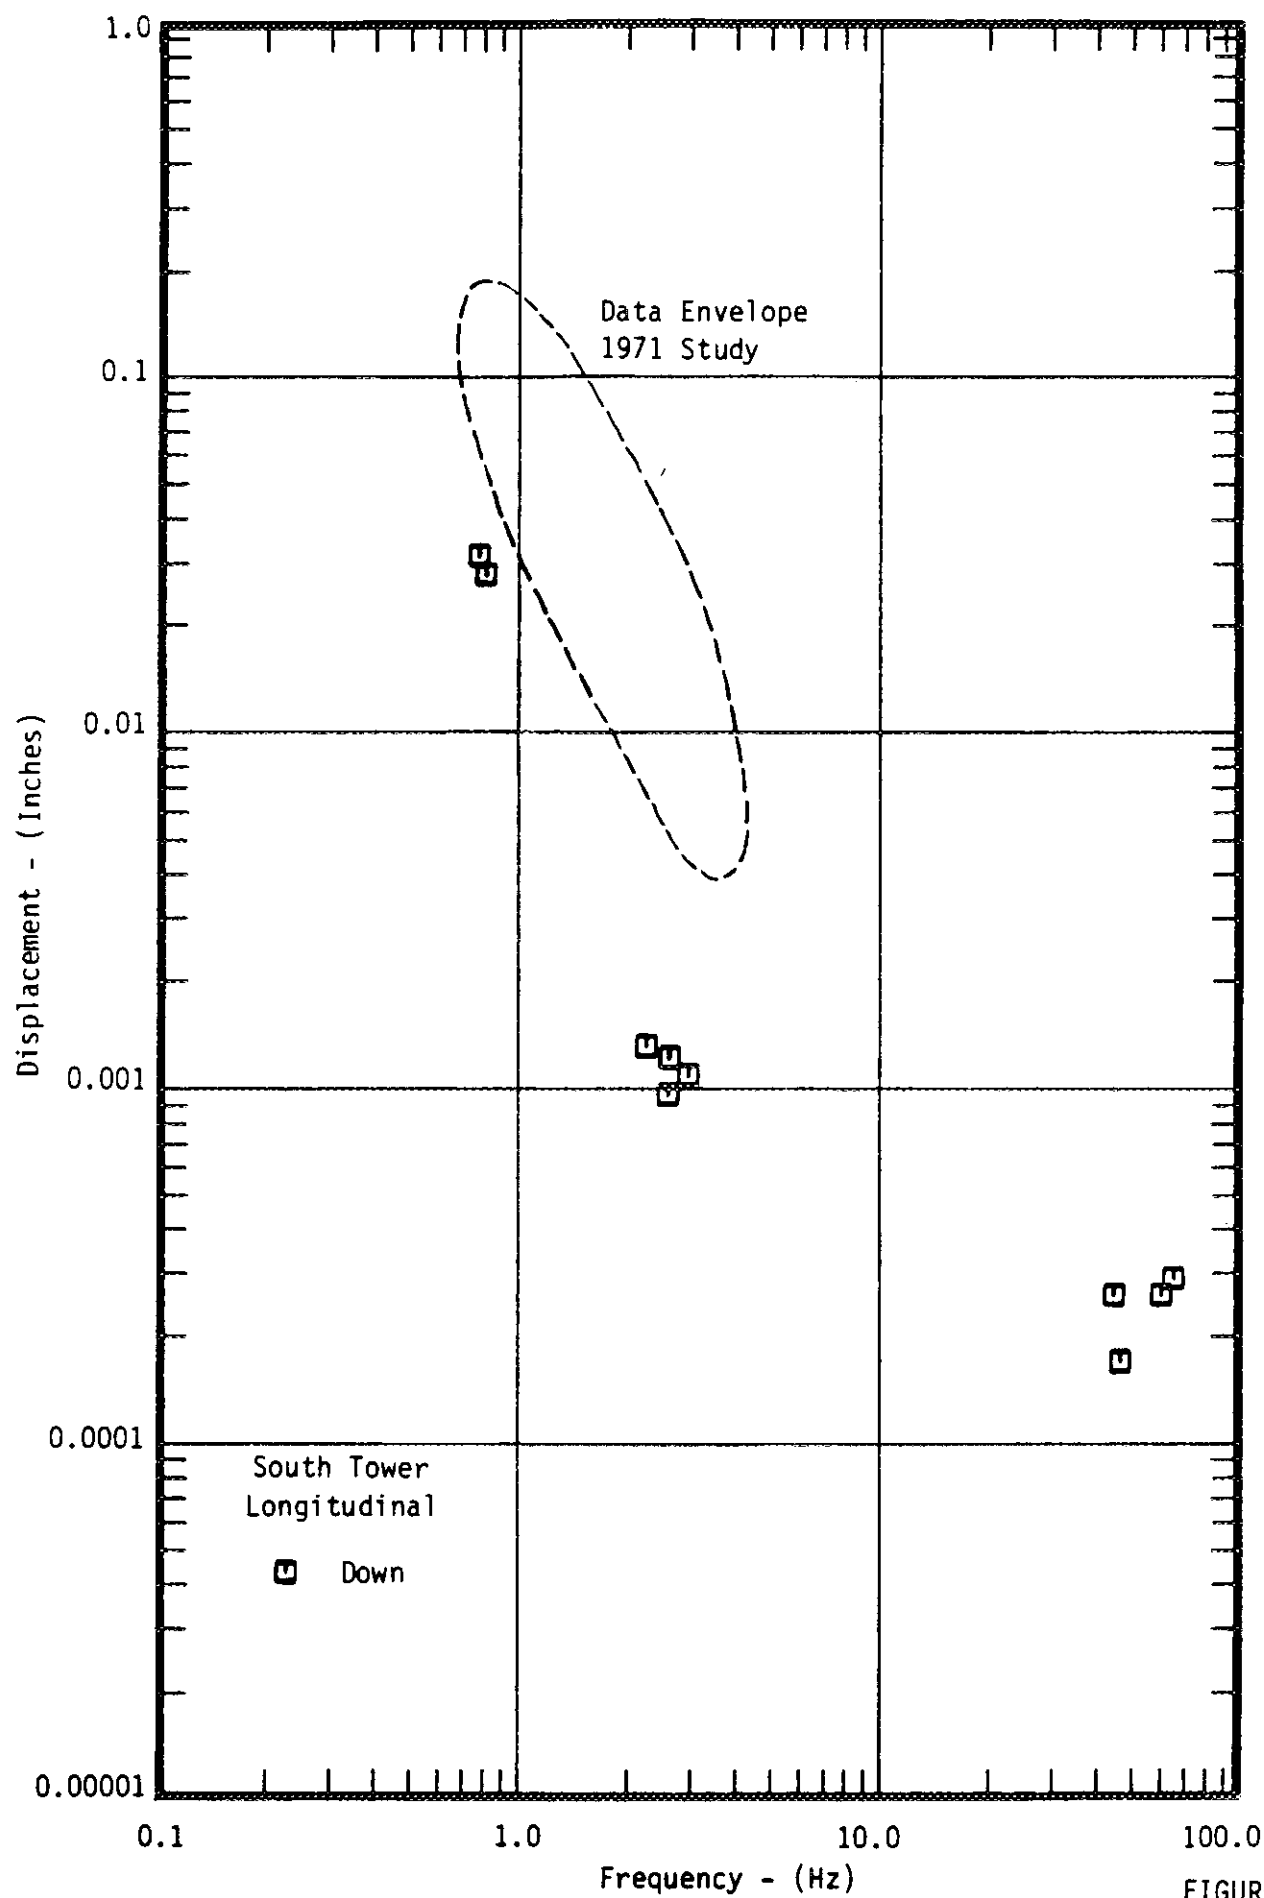
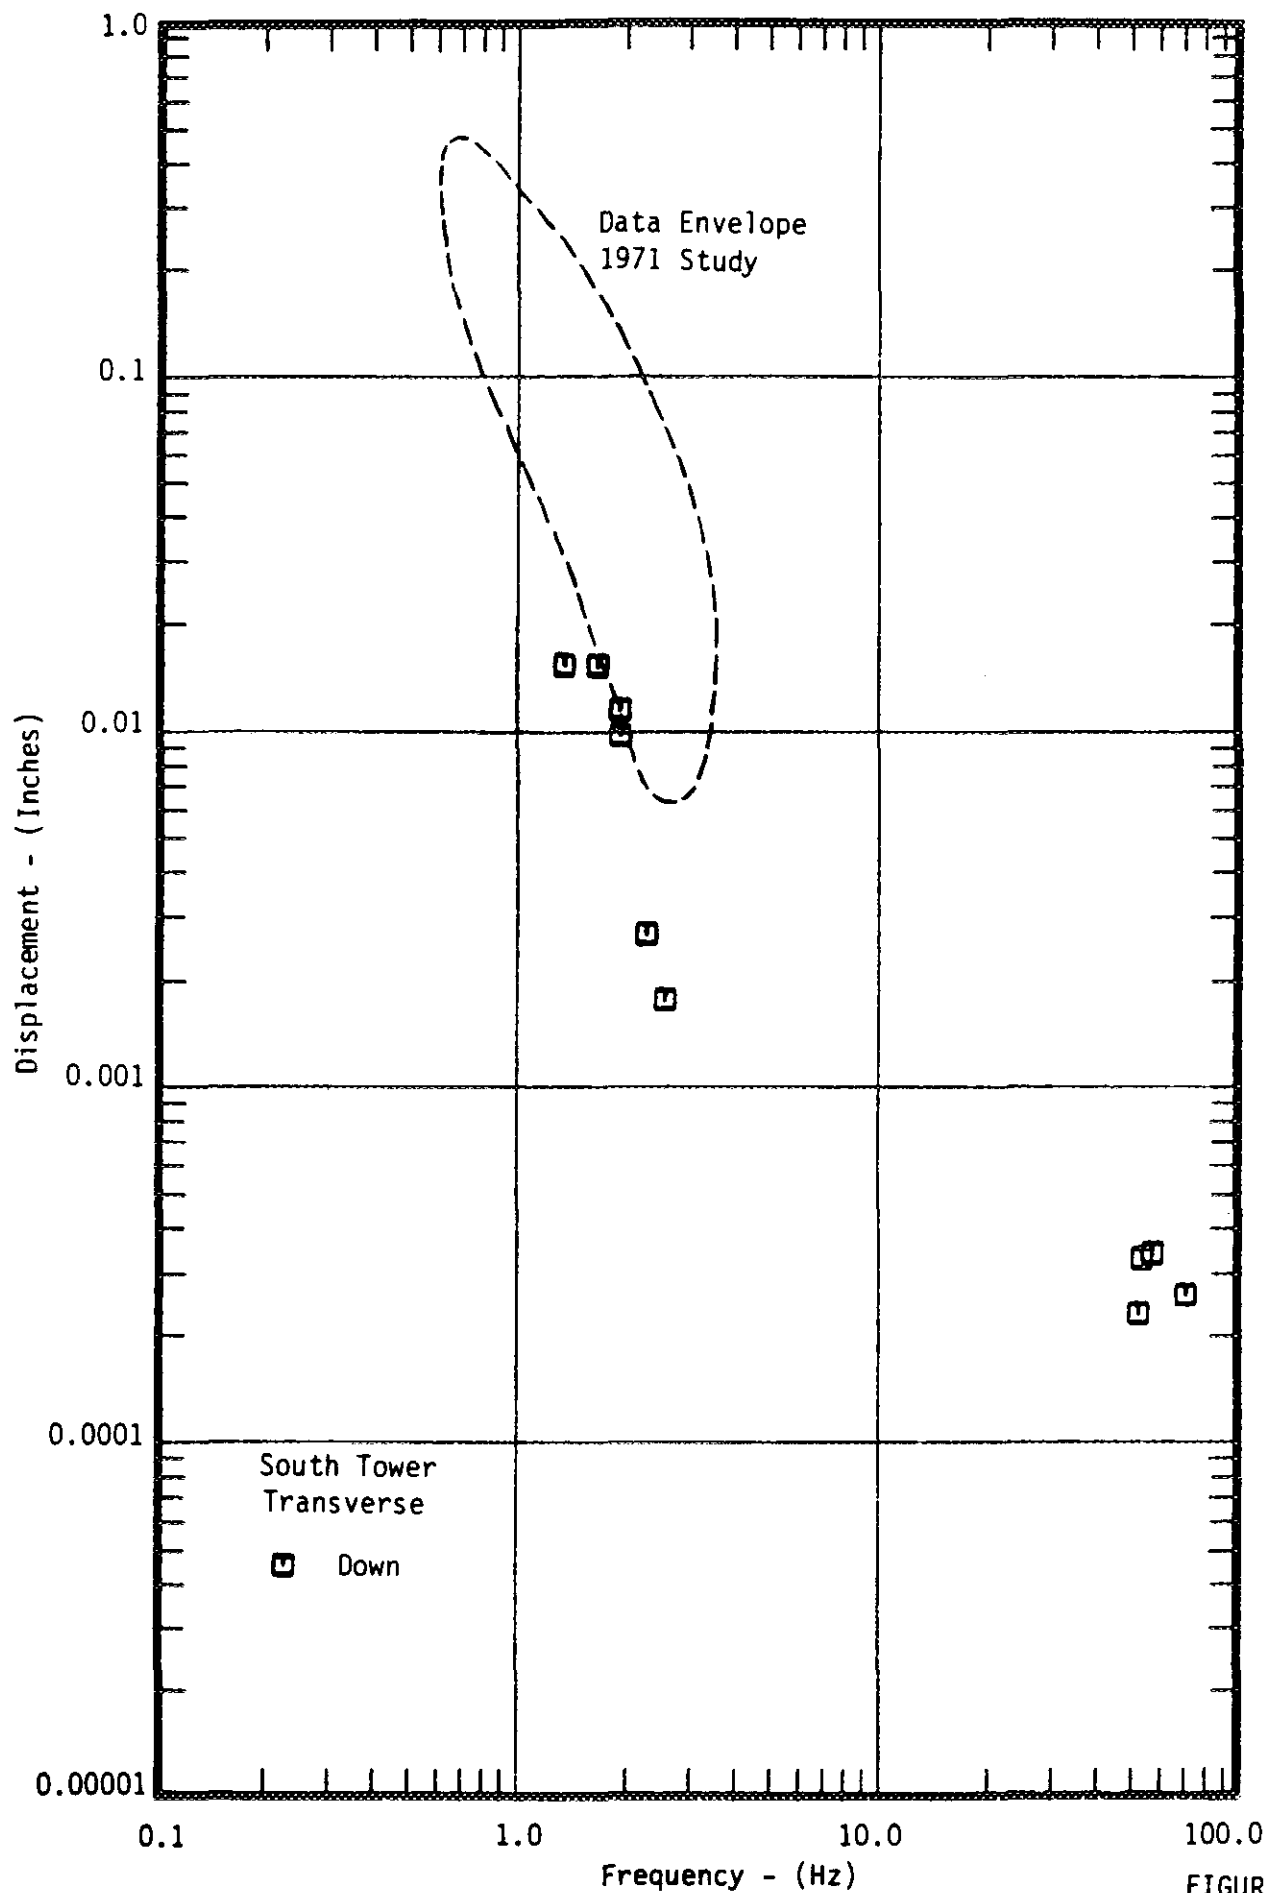
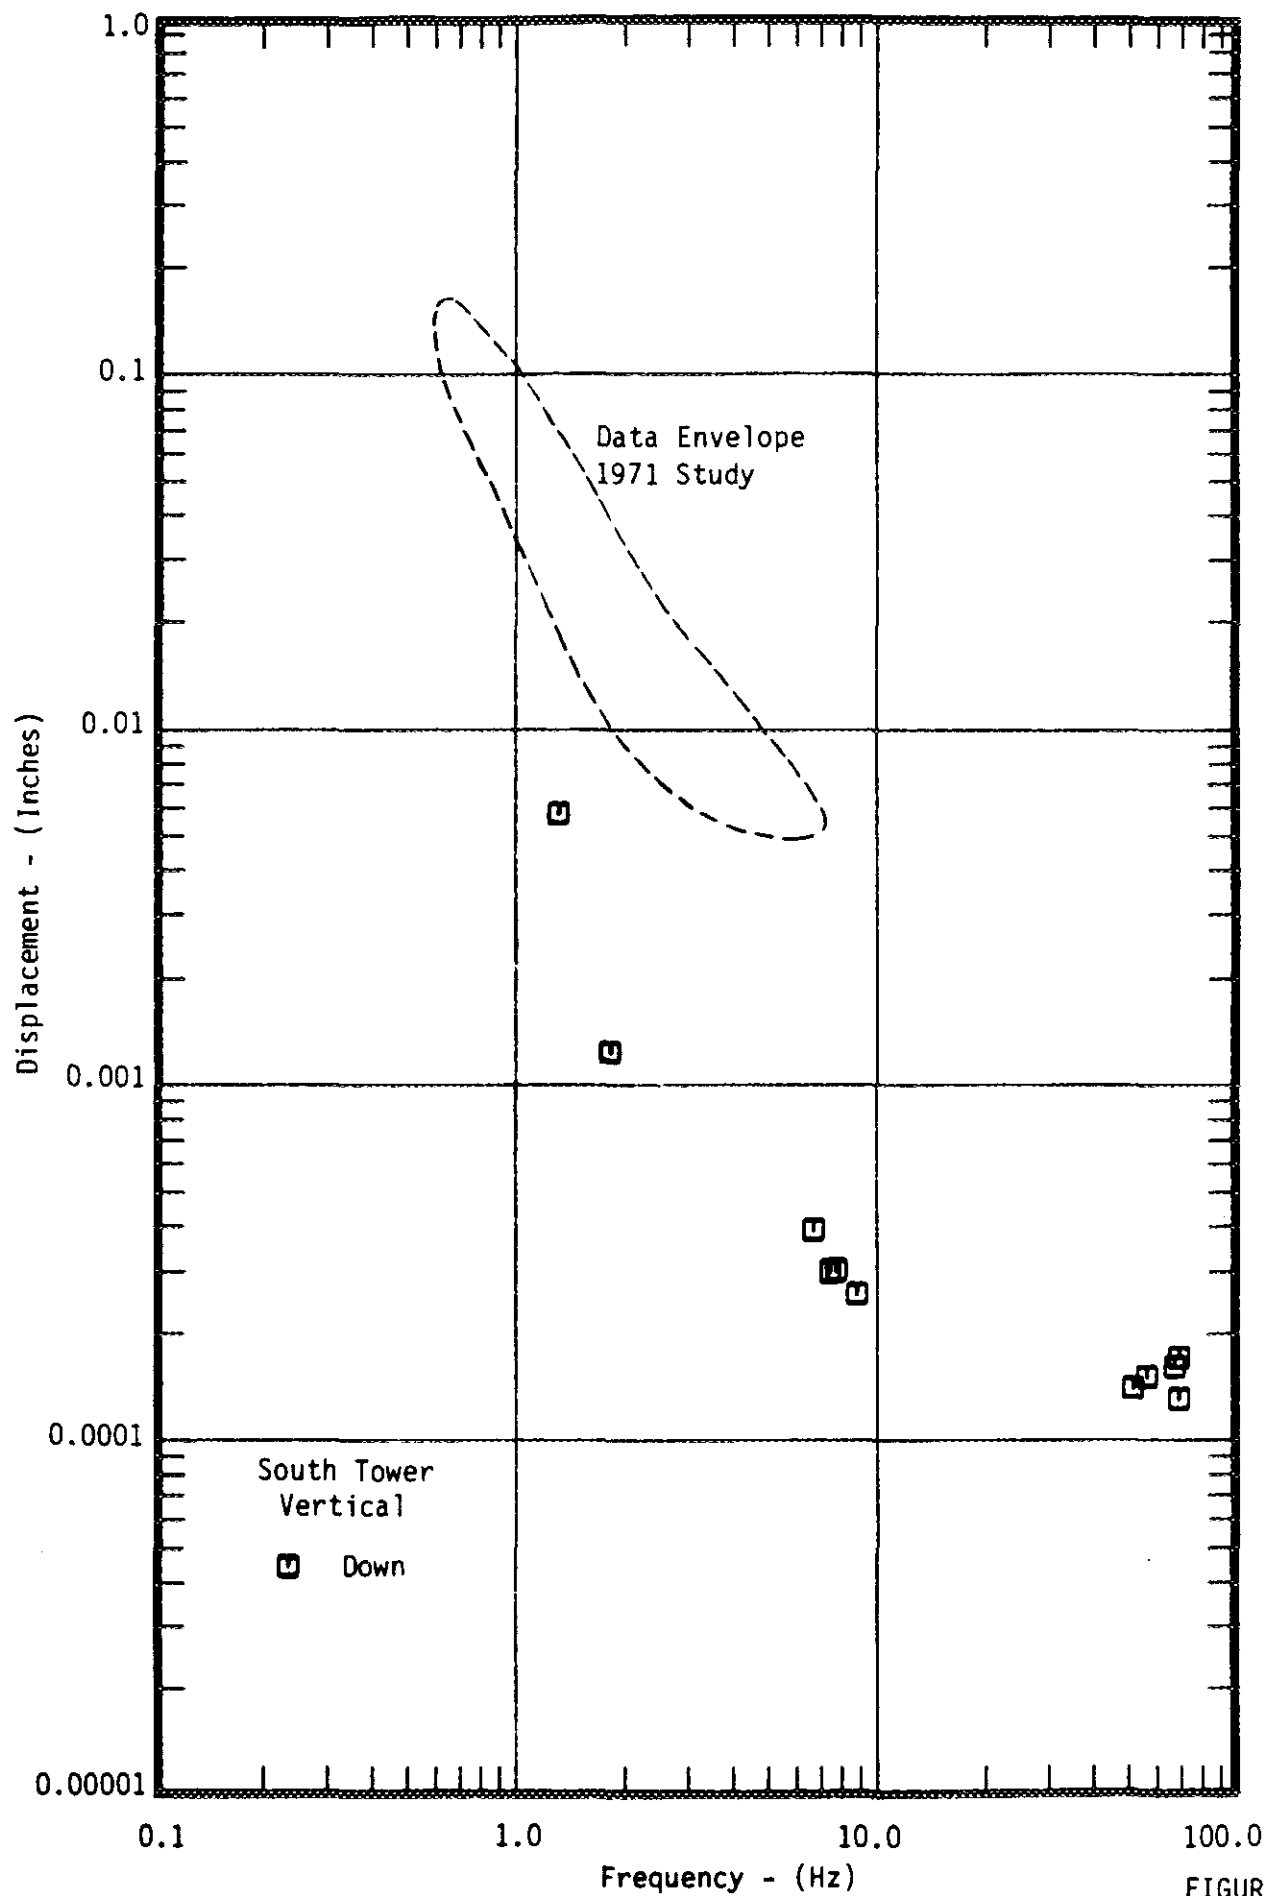
Displacements in the South Tower for downward movement of the lift span are compared to the 1971 results on Figures 14→16. As for the case of train vibrations reported at mid-span in the 1971 study, vibrations reported in that study for the South Tower seem high. Records obtained in 1971 for the South Tower have been re-interpreted; the re-examined displacements are plotted on Figures A-4 through A-6 in Appendix A. The re-examined records provide results that fall below or within the lower range of displacements quoted in the 1971 study.

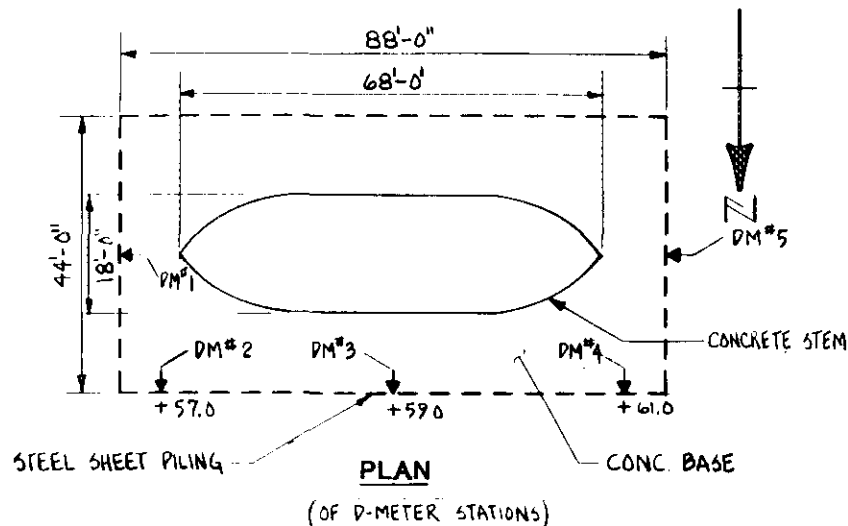
FIG 597-84-2

The steel sheet piles are generally in good condition. Ultrasonic steel thickness readings indicate a minimum steel thickness of .215" (flange), however, average readings were considerably higher (.330" web; .400" flange), see Figure 597-84-2 for thickness readings, locations and elevations. The cleaned surface of the steel is slightly pitted with a maximum depth of less than 1/16" (see Photo #9). Corrosion by-product which covers the steel is 3/8" to 1/2" thick with an outer layer of hard, crusty material. Below the outer

LOCATION OF IMPACT DAMAGE TO SHEET PILES
SEE FIG 597-84-3 FOR DETAIL

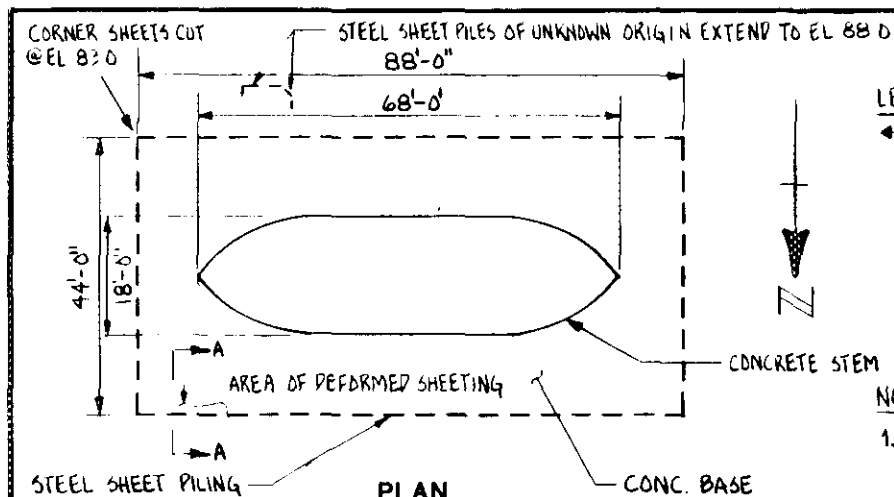
FIG 597-84-3

Along the northeast corner of the concrete base there is an 8-foot section of the steel sheet pile wall which has been damaged. The damage begins at the northeast corner and runs to the west at the top of the sheet pile (El. 75.0 to El. 65.0). In this area the steel sheeting has been flattened and folded over the concrete edge (El. 75.0) to the southerly direction (see Photo #10). Due to the deflection and deformation, there is one hole (1"x5") in the flange of the fifth sheet as counted from the corner to the west at El. 74.0 (see Figure 597-84-3). There is some local crushing of the concrete in this area, however, this damage appears to be minor.

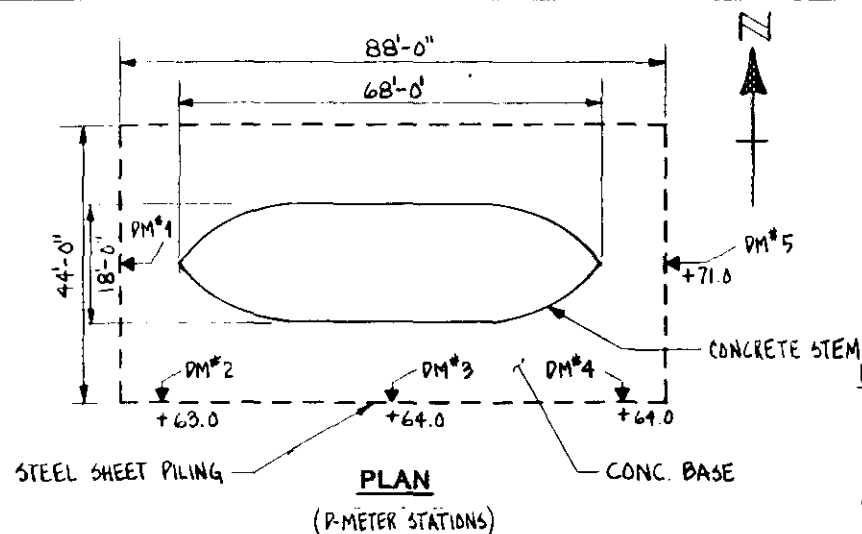
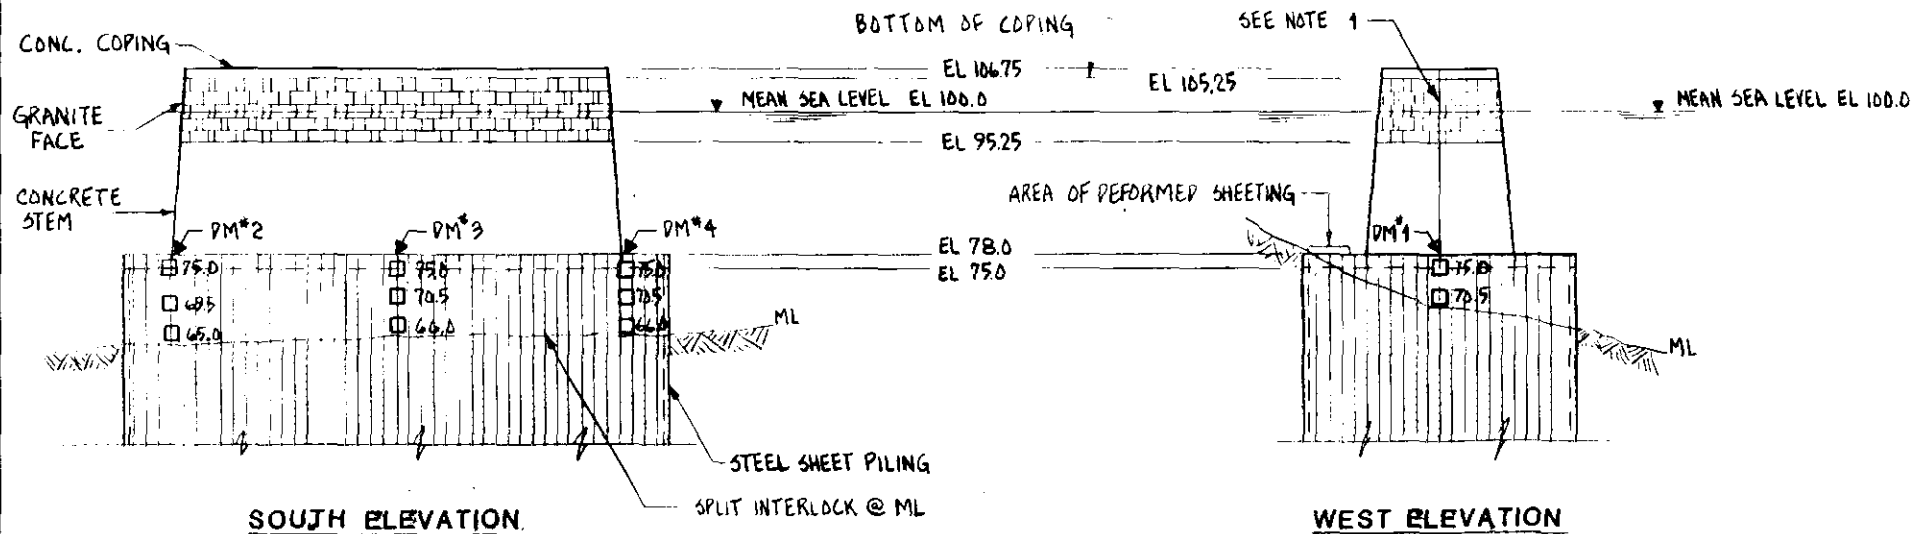
FIG 597-84-4

The steel sheet piles are in good condition. After cleaning the surface of the steel, slight pitting was observed on the steel surface with the pits being less than 1/16" deep (see Photo #17). A corrosion profile of the steel is similar to Pier B with an outer layer of hard, crusty material. Behind the outer layer are trapped pockets of gas and a soft black layer of corrosion by-product (see Photo #18). Ultrasonic steel thickness readings indicate a minimal steel thickness of .205" (flange); however, average readings were considerably higher (.390, flange; .315, web) see Figure 597-84-4 for thickness readings, locations and elevations.

1. APPROX. 20 LF OF DETERIORATED JOINT GROUT IS NOTED @ THE WEST END OF PIER C AT EL 109.25 AND 101.25 TO A MAX. DEPTH OF 6"
2. CONCRETE STEM DIMENSIONS TAKEN @ EL 105.25
